Brecon Beacons National Park Authority

# Talgarth Conservation Area Appraisal

September 2016

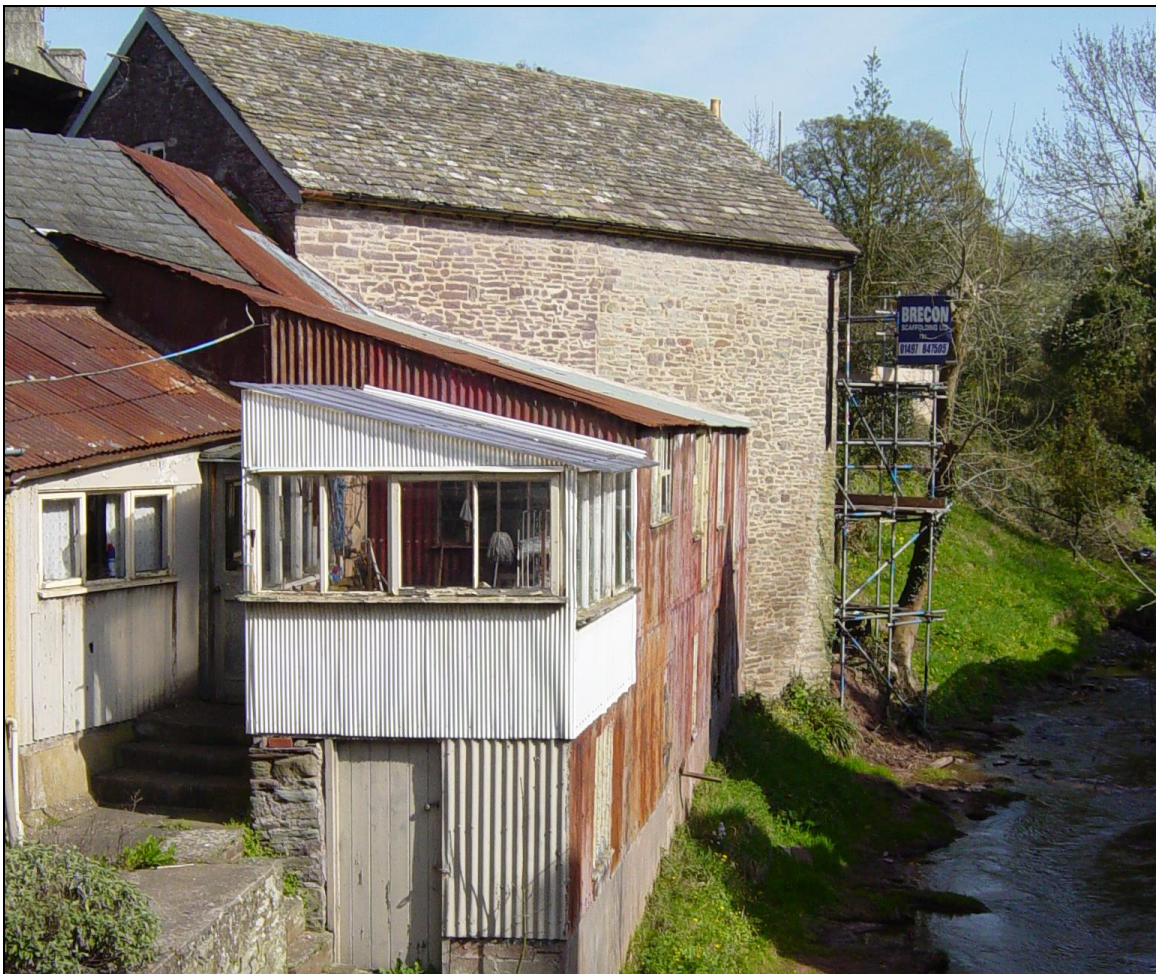
***The Town Mill***

have a series of identical layouts, in line. The Great House Barn is an outstanding L-shaped structure, of two storeys, originally with a storage wing and an attached cow house and provision for over 240 pigeon nest boxes in a gable end. The Mill is C19, three floors and with an overshot water wheel on one end and Glanant, by the river has ground floor storage cellars.

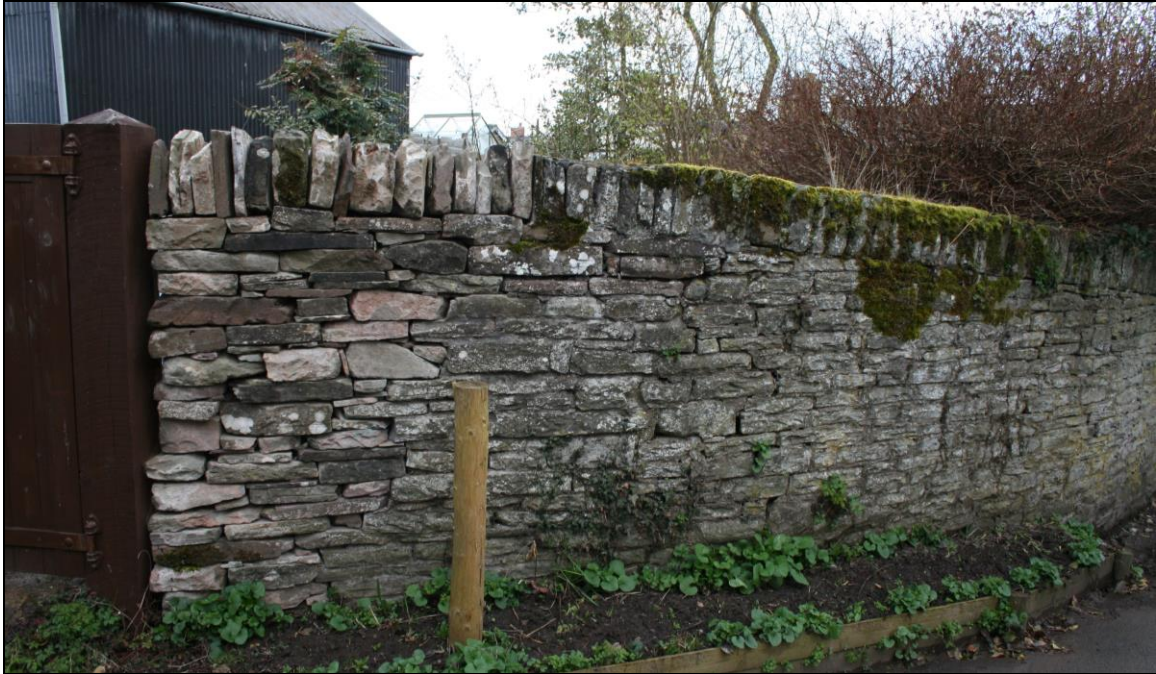
*Roughly coursed and dressed walling with vertical coping*

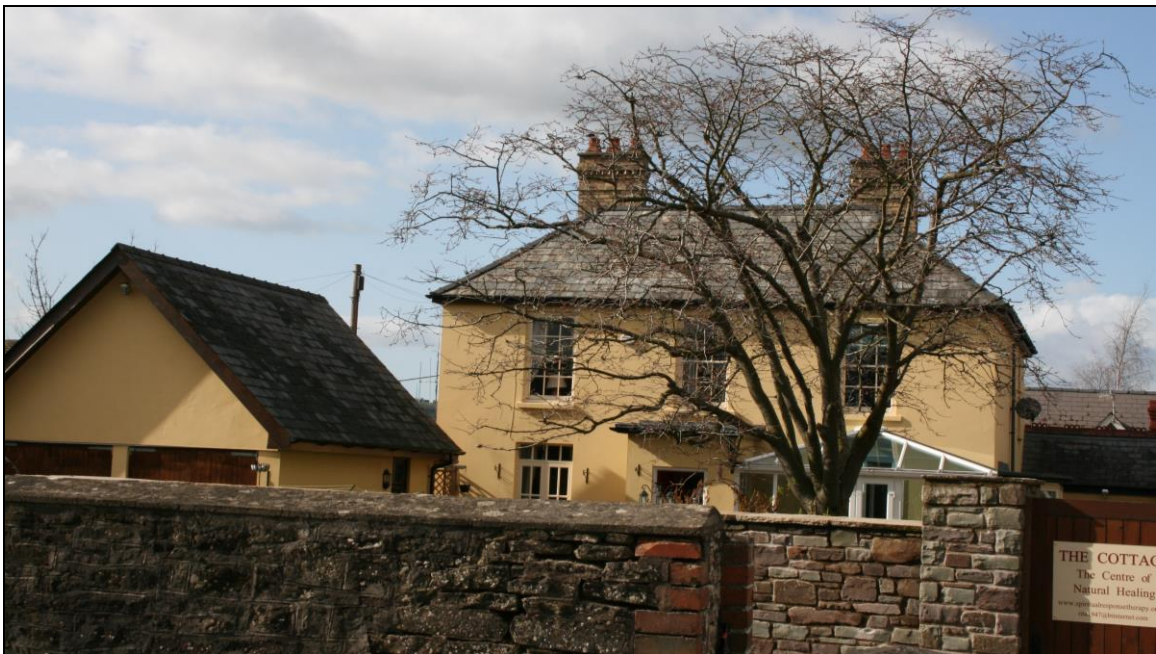
***The Cottage***

- The Cottage, on the west side of Hay Road, a mid-C19 detached house, rendered, hipped roof, end chimney stacks, with a central porch, first floor 6/6 sashes and ground floor French door – an unusual house type in the town;

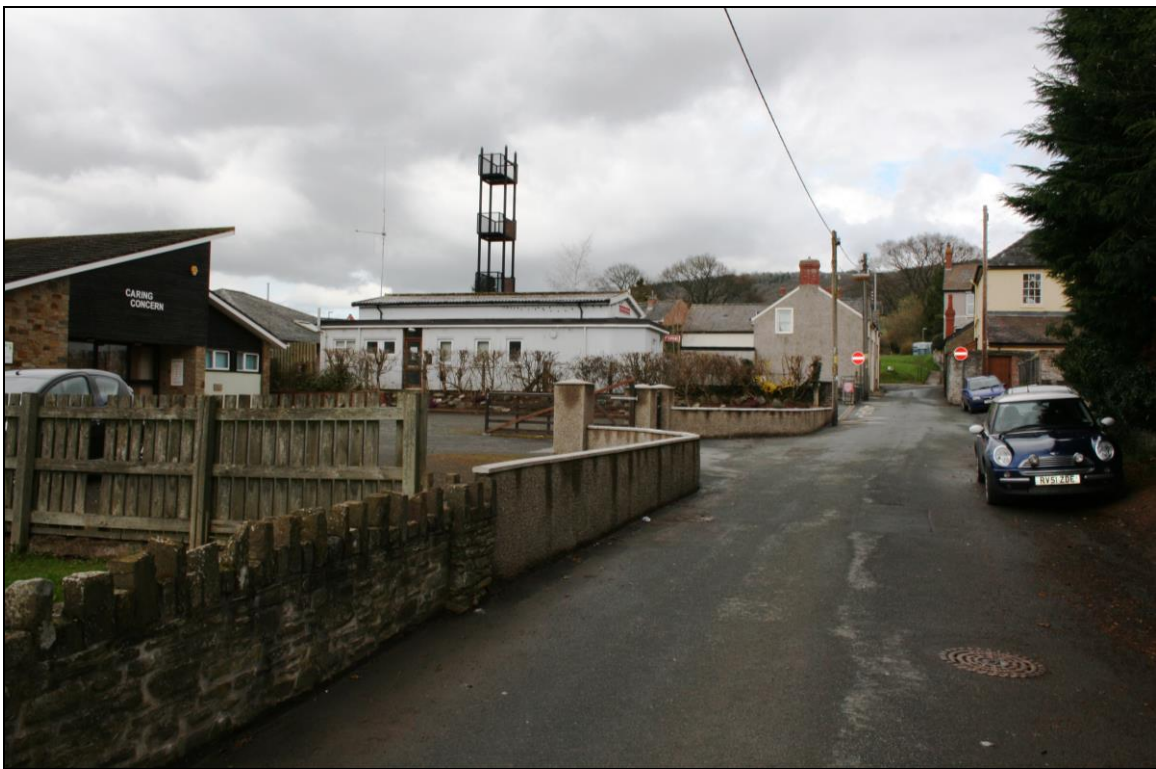
**8.5** The **extent of intrusion or damage** is an important issue, with impacts of modern development in limited areas and erosion of traditional details on a number of unlisted buildings of group value. There are several large modern buildings, including the Library and Fire Station, off Bronllys Road, that have a negative impact on the conservation area because of their large scale, lack of or inappropriate detailing, alien materials and the large, bare areas of car parking surrounding them. The Church Hall, on Hay Road, is another rather bleak and bare structure and the extension to the Natwest Bank detracts from a characterful main building.

***Modern buildings introduce a larger scale and unattractive surrounds***

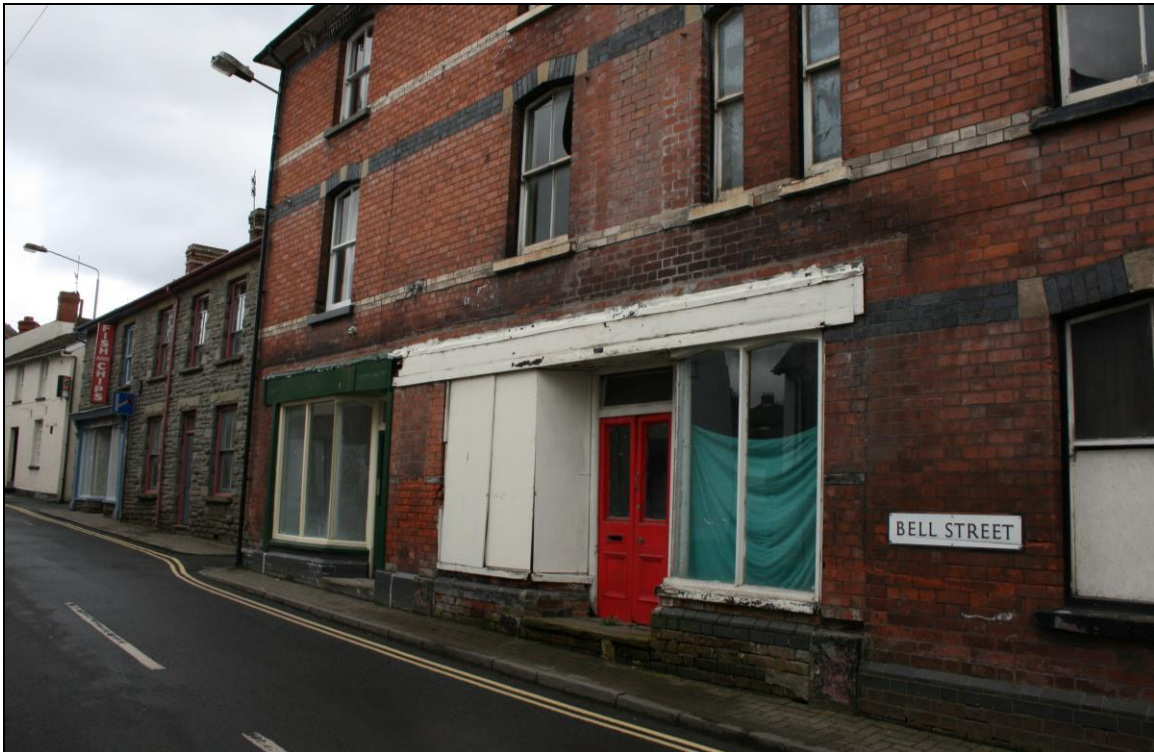
***Problems with former commercial premises, Bell Street***

- 8.7** There is evidence of buildings in poor structural and cosmetic condition (see 8.9 below) and areas, like Bell Street, are blighted by the concentration of several vacant or underused structures. The Mill has been of concern for a long time but repair and conversion for a variety of educational and community uses has been the subject of a successful bid for substantial Heritage Lottery funding. Mill Cottage will also benefit from this project. Some of the handsome C18 and C19 gravestones and memorials at the parish church and the chapels are affected by stone erosion and structural issues. Many C19 houses and cottages have been affected by changes in window and door details, through Permitted Development provisions. PVCu windows and doors may approximate to traditional patterns of glazing and door panels but they may introduce alien details, textures and reflections. Some replacement wooden windows do not reflect traditional details and the use of dark brown stain for woodwork in general adds a dour note to elevations of buildings. The unity of terraces has been affected by individual, piecemeal changes and there are a number of individual buildings, in Penbont Road, Back Lane and High Street that would have merited noting as locally important buildings but which have been compromised by recent building work. There may also be examples of unauthorised development works, such as rear extensions and ancillary buildings that should be the subject of an enforcement audit.

**8.9 Condition of Built Fabric:** there are obvious problems with key historic buildings, such as the basement of the Town Hall (the subject of a detailed architectural study), the Mill and Mill Cottage and the commercial premises in Bell Street. There is a pair of C19 houses in Regent Street that appear to be in very poor condition and several houses have paintwork requiring attention (where windows have not been replaced by PVCu). The memorials in the parish churchyard are in varying states of repair, with some of the older ones suffering from spalled surfaces or structural problems, necessitating dismantling or removal in some cases. Memorials at the Presbyterian Church appear to have been stacked against a side boundary wall.

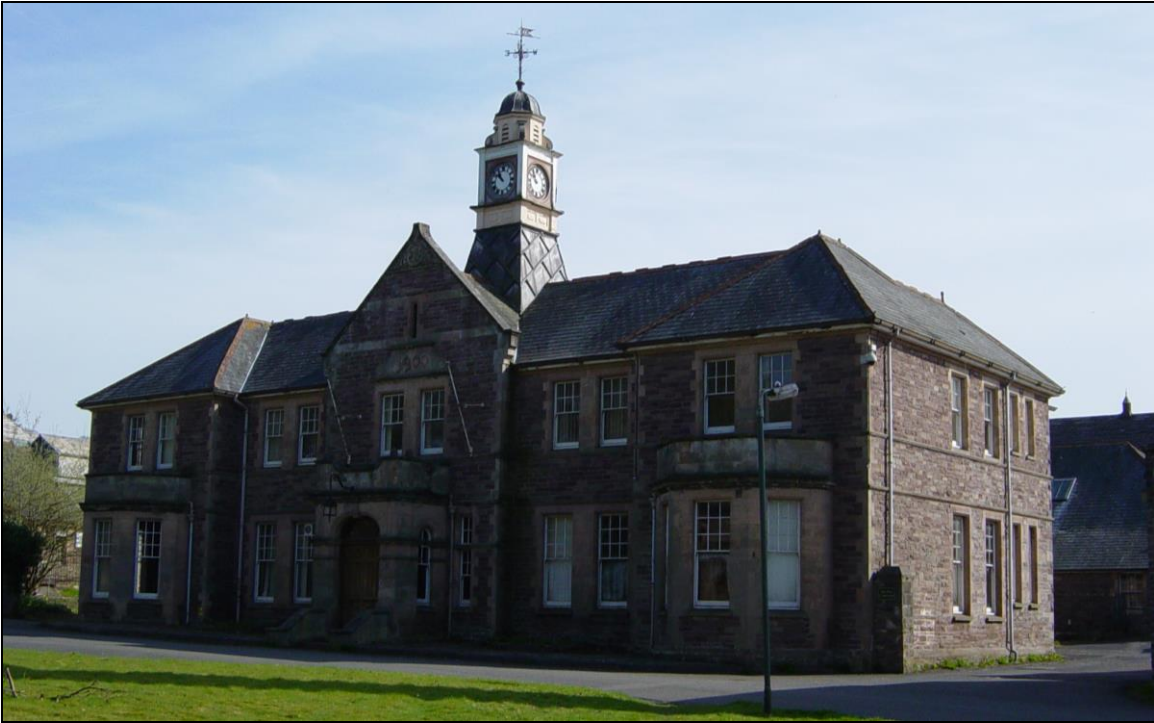
**Mid Wales Hospital site**

notably staff houses or 'villas' along the southern access road to Talgarth and to Pwll-y-Wrach and a large, detached house, Chance Field, to the north of the main complex. The complex of hospital buildings, main entrance block, great hall, separate chapel, mortuary, boiler house and laundry and other specialised treatment facilities was originally designed by *Giles, Gough and Trollope* in 1900. The hospital buildings are laid out in a symmetrical 'butterfly' plan, with a series of pavilions positioned either side of the central entrance and hall blocks, linked by corridors. There are various modern extensions and buildings but, in the main, the site retains a strong early C20 character.

- 10.7** The hospital buildings have been unused since the late 1990s, apart from some commercial use of a few units to the east of the main complex. There has been systematic stripping of slates and lead, resulting in damage to the former main hall. There have been attempts to list some or all of the group, but these have been, to date, unsuccessful. A range of uses for the site has been discussed with the private owners but, apart from the limited commercial use and the successful conversion of the Waun Fawr buildings for residential and tourism accommodation uses, the main complex is in obvious danger of further damage and, potentially, loss.
